St. Mary On Lastre Church In Beram, Istria, Croatia -Multidisciplinary Research, Recommendations For Restoration And Further Maintenance

Irma Huić¹; Martina Vujasinović²; Mladen Obad Šćitaroci³

¹ Croatian Conservation Institute, Zagreb, Croatia; ² Lokosek project d.o.o., Zagreb, Croatia; ³ University of Zagreb, Faculty of Architecture, Zagreb, Croatia

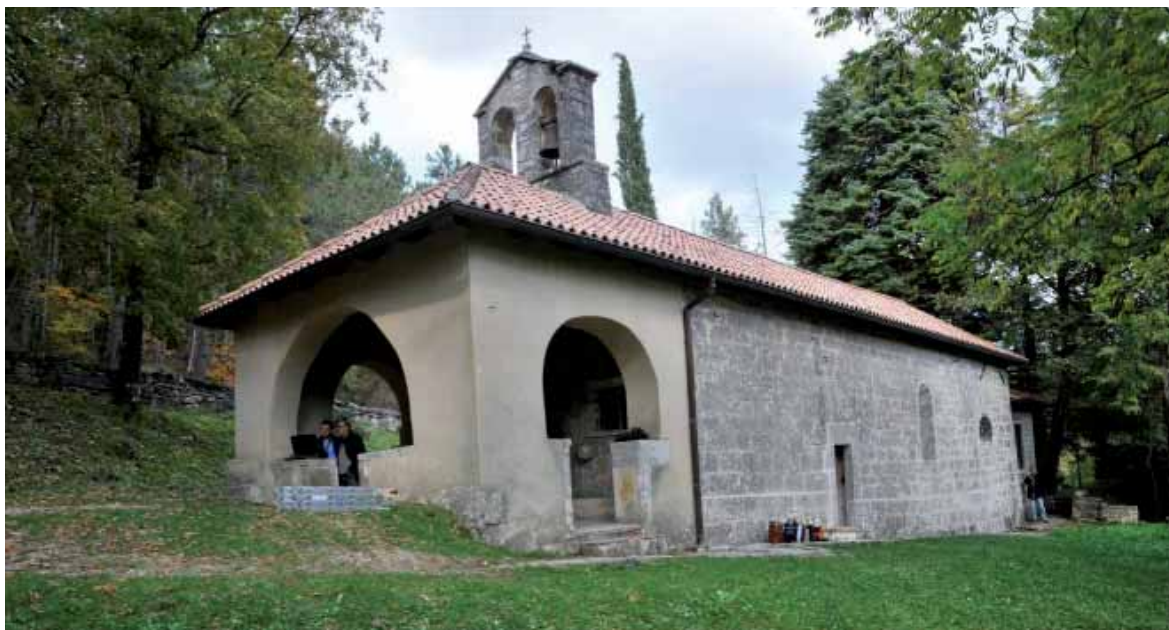
The exterior of the church of Saint Mary on Lastre, view of the south facade

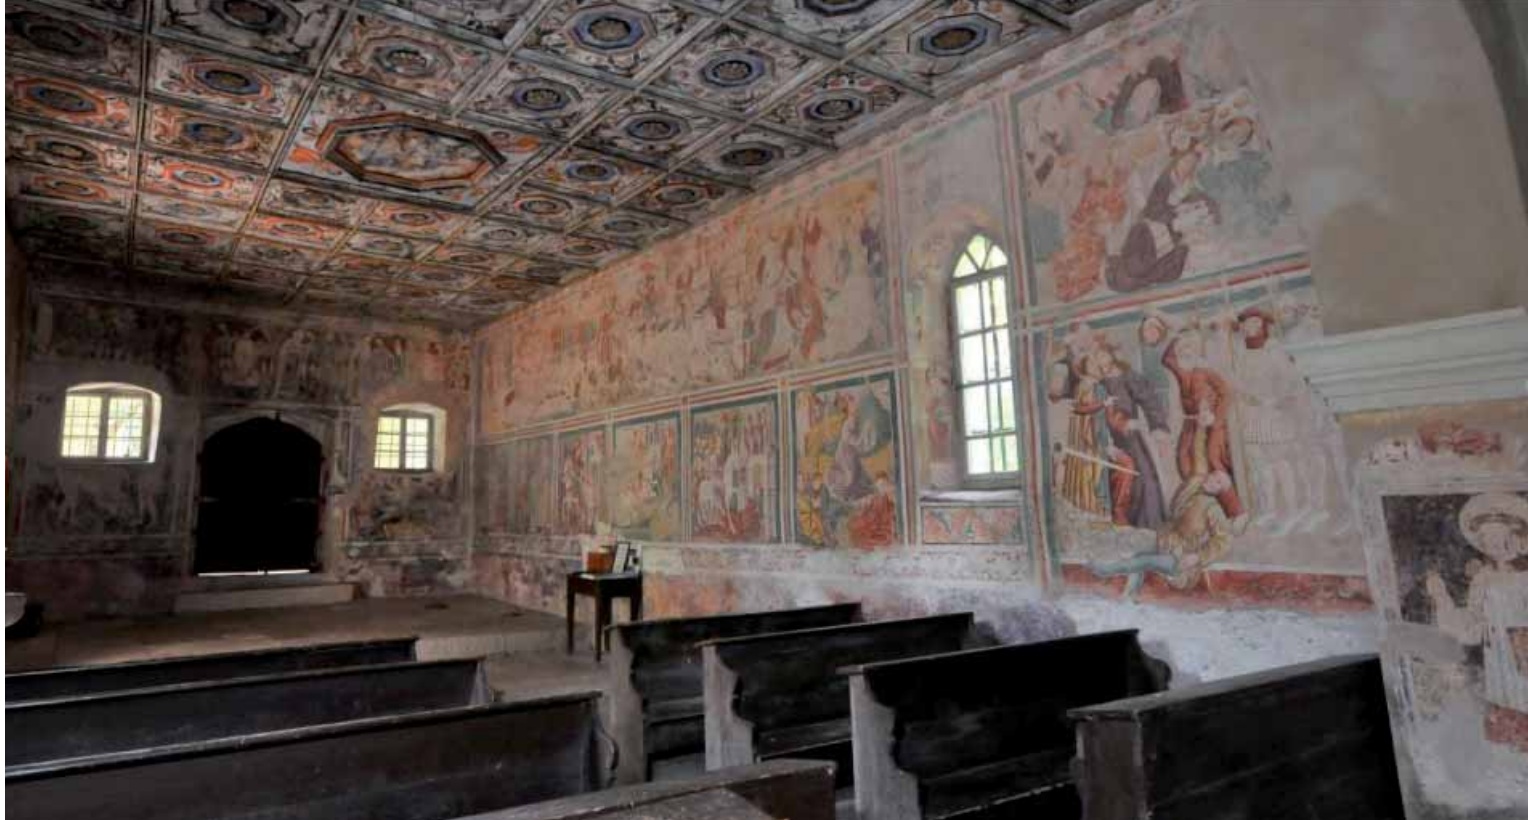
The interior of the church of Saint Mary on Lastre, view towards the northwest corner

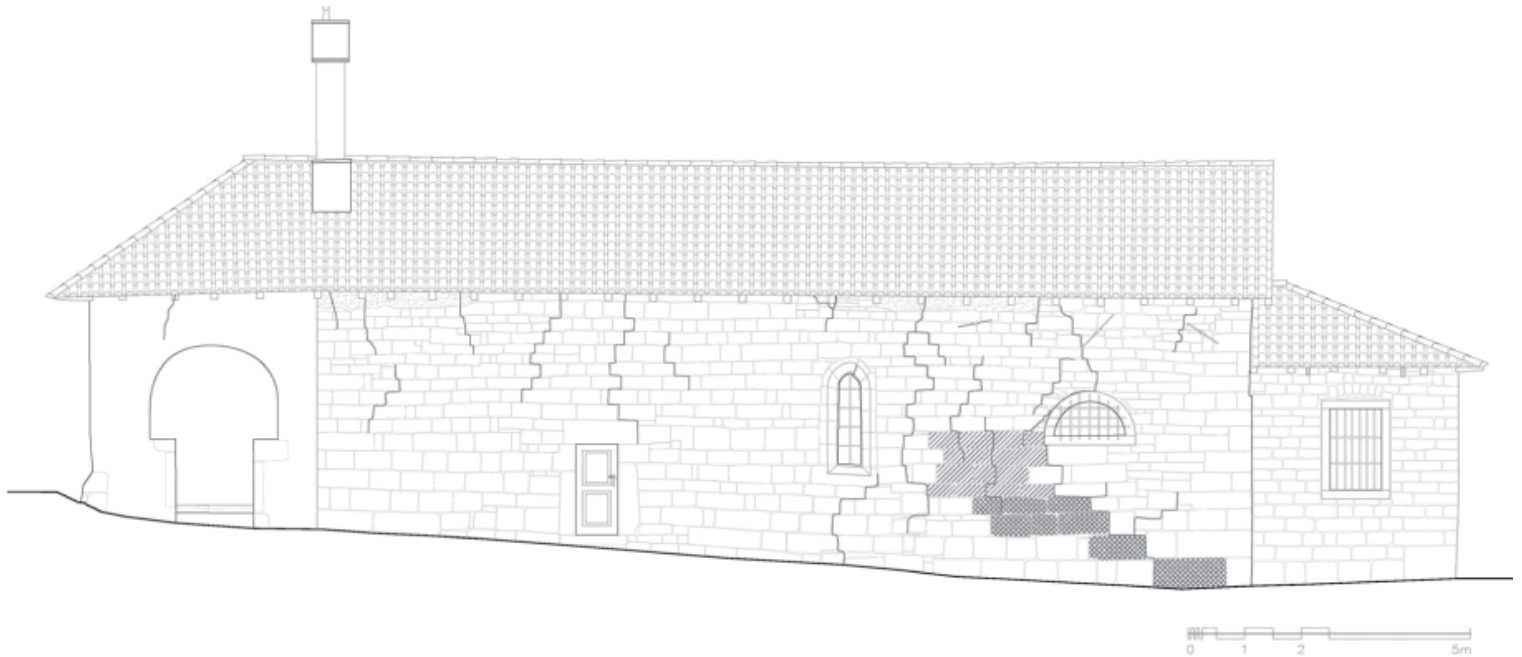
In the last forty years on several occasions geotechnical and constructive research works have been undertaken. The research activities started in 1969 because of the large-scale constructive damage on the southern and western walls of the church that also caused the damage of the mural. Also, inside the

Church of Saint Mary on Lastre, South Façade with construction damage

building, high humidity and capillary moisture was visible. The supporting wall of the plateau had a large deformation in the middle of its overall length.

As the result of this first research, it was concluded that the ground beneath the church had been moving, however the reasons of this moving had not been discovered, nor was it successfully stopped.

First, the need to implement a new system has been proved, as well as the need to strengthen the supporting constructions that should be able to stop the horizontal movement of the plateau's ground on which the church is situated, the shifting of which has caused the subsidence and with it the appearance of new damage on the already damaged overall construction. The existing supporting constructions need to be adequately connected and anchored into the stable ground.

After that, the focus should be shifted to the second part of the works which include the overall consolidation of the built structure that has through years been, due to the uneven foundation on the ground, exposed to the washover of the subterranean waters, local subsidence and horizontal sliding of the whole width of the church zone. Consolidation should start with the control of the building's foundation, especially the whole southern wall, to estimate and fix possible inconsistencies. In agreement with the restoration team and under their constant supervision, a minimally invasive way of injecting crevices and walls would be defined, by which all the wholes within the stone structure would be fulfilled without the negative influence on the valuable wall paintings. To restore the original mechanic characteristics of the wall and strengthen it additionally in case of minor additional settlements of the ground, the installation of the stainless steel ancor prods thick as the wall is foreseen to strengthen the critical areas in a minimally invasive way.

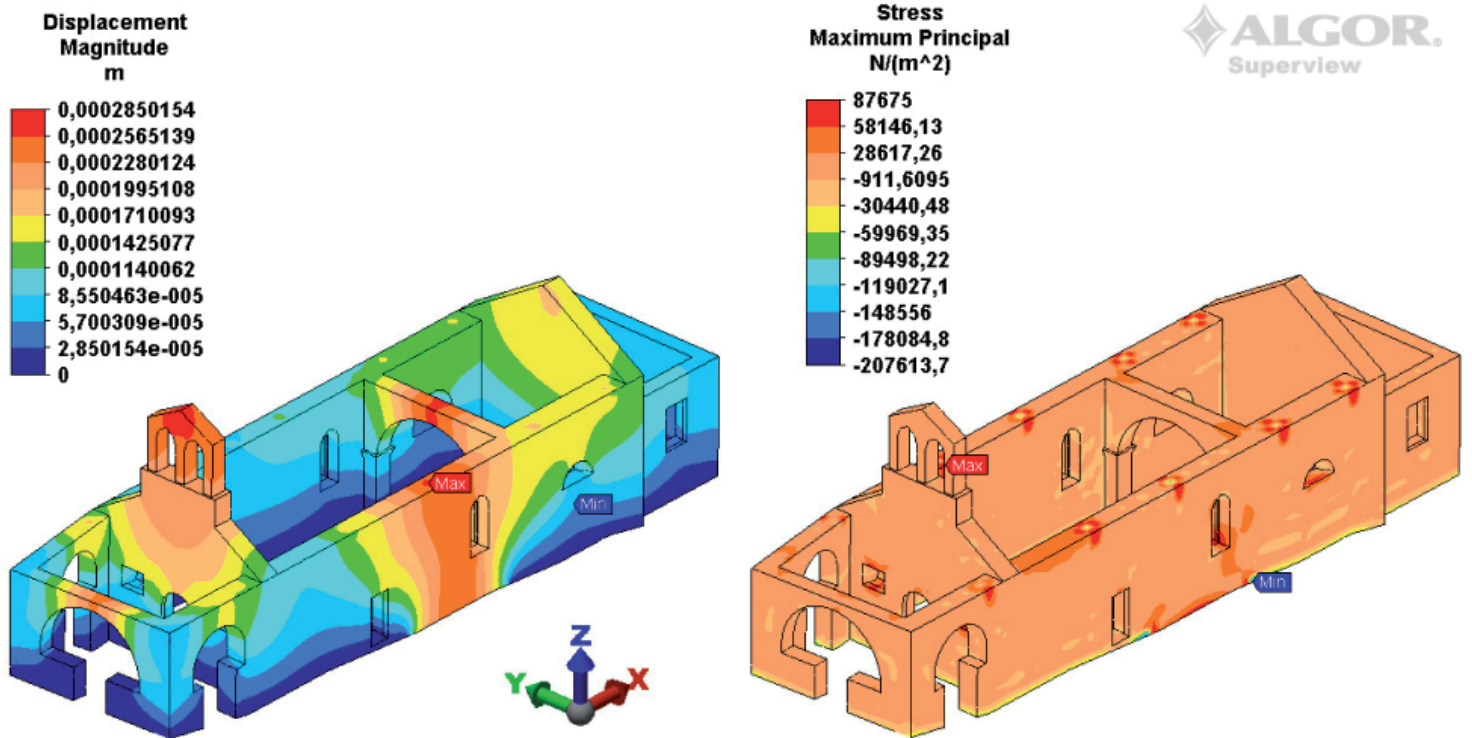
Church of Saint Mary on Lastre, analysis of the existing state of the supporting construction on a three-dimensional model

proved that within the construction itself there are no larger inconsistencies and weak points that would cause existant widening of the crevices. The lack of the foundation on a part of the southern wall, and exactly on the part that is weakened by the openings into which also a triumphal vault is fixed, is the reason of the wall protrusion and shifting of the stone pieces in that part. The same damage as such are evidenced on the photographs that date 40 years ago. In the meantime, that part of the wall in the lower area was strenghtened by concrete, but it had not been consolidated which still causes the crevices to move, obviously because of the ongoing movements of the terrain [Lokošek, 2012].
