SPA GARDEN IN DARUVAR – METHODS OF RENEWAL AND RECONSTRUCTION

Abstract: *Spa garden in Daruvar 'Julius's Park' is the oldest spa garden in continental Croatia. The counts Jankovich and their successors created the garden during the 18th and 20th century. The garden resumed its nowadays form and surface in the time of count Julius Jankovich in the mid-19th century and it was named after him. The garden is protected as a cultural heritage. The garden's renovation is seen as an urban, architectural and landscape unity and it attempts to affirm the missing and neglected parts of the garden, to provide technological and municipal space modernization and to make a pleasant urban garden ambiance with new facilities and high space arrangement qualities, contributing to the economic development of the local community.*

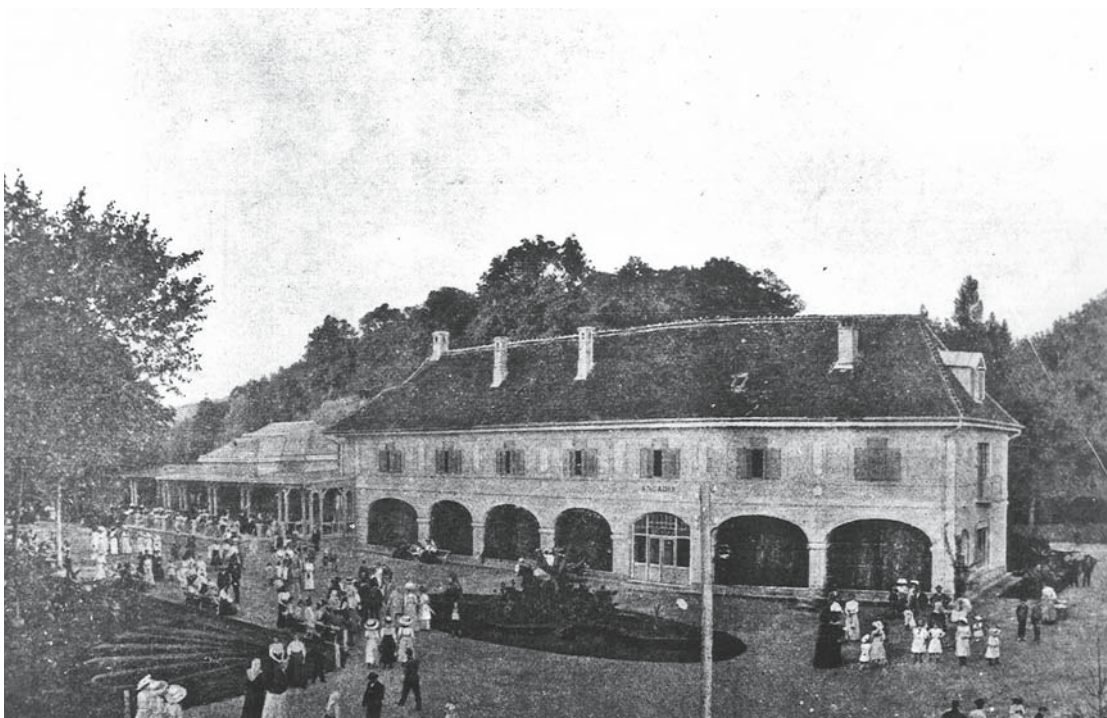
Figure 3. Ornamental parterre of spa garden, the atmosphere in the garden 1914, source: Croatian State Archives

Since the garden was not an expression of one style and idea, but developed in several phases, it contains diverse characteristics and styles. Baroque features are recognized in the hornbeam avenues of the garden's Northern part, initially cut as trimmed walls, and the neo-baroque in parterre flower-gardens in the Southern part of the park. The park also has features of historicism and late romanticism. Hornbeam avenues and some old trees are preserved even today. Boxwood decorations and flower gardens originate mainly from the first half of the 20th century. There are a lot of tree species in the garden today, many of them were planted in the middle and in the second half of the 20th century.

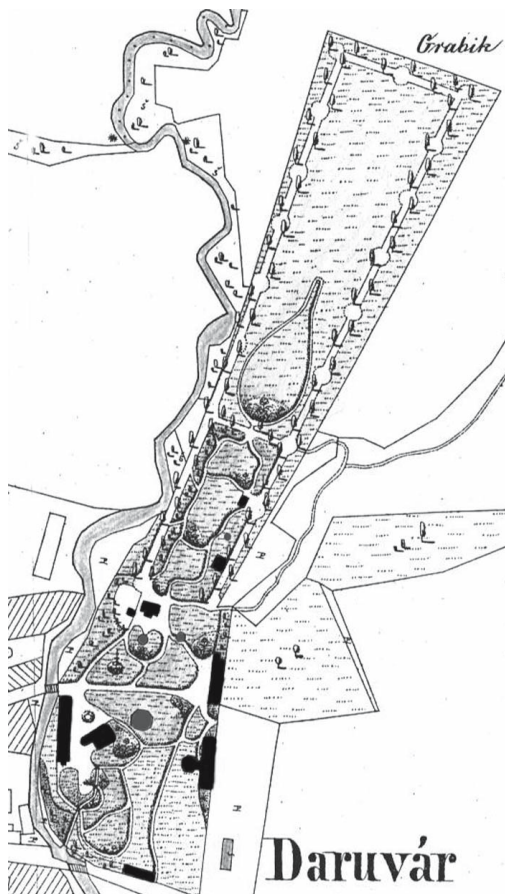
Figure 4. Cadastral map, 1861.

The oldest graphic representation of the park was made in the cadastral map in 1861. The garden was owned by Julius Jankovich and experienced its greatest flourish at that time. The bathing area covered around 650 m² and the garden even 6.15 acres. Some of the buildings vanished as well as the numerous facilities, but one can still feel the historical spirit of the landscape. [5]

Five cadastral maps of the garden (from the 1861, 1896 and 1954) were available. With these maps the historical appearance of the garden, important for reconstruction, could be determined. Numerous old photographs and postcards (mostly from 1920 and 1930) were also available.

A cadastral map from 1861 was considered to be a historical matrix, therefore the starting point for reconstruction. It was created by a careful tracing of gardens' changes in historical cadastral maps. Three historical cadastral maps (from 1861, 1896, 1954) were put to overlap each other, as well as the maps of the current situation, in order to compare the historical layouts and to identify similarities and differences. The greatest attention when researching the historical matrix was focused on historical paths, promenades and flower gardens.

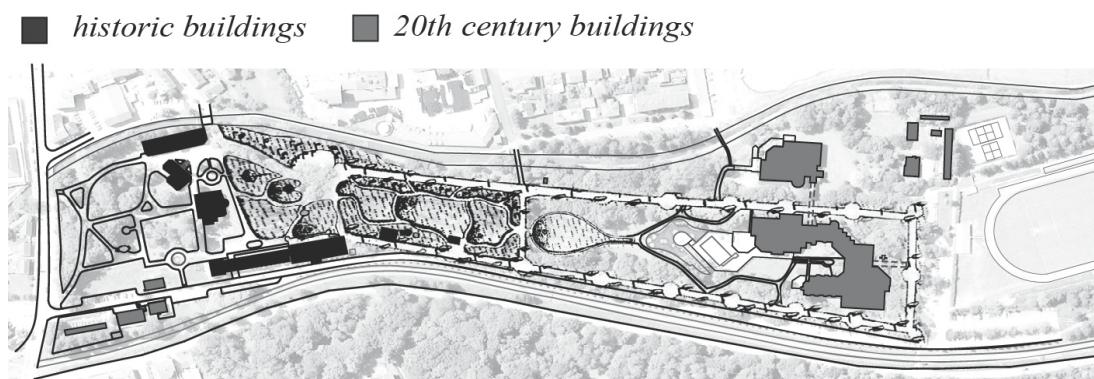
Figure 6. The layout matrix

In addition to the layout image, the garden interior and, to the possible extent, the historical city park atmosphere will be renewed. The most important layer in the park is the one from 1861, or from 1896, because the differences of the layouts are insignificant.

The layout matrix of the garden and garden composition are the result of the research and the main reference for the garden's renewal. (Fig 1, Fig 2) They are a basis for the making of further project's documentation. The problems of historical change and renewal were identified, which is a valuable contribution to the applied methods of renewal and preservation of cultural heritage.

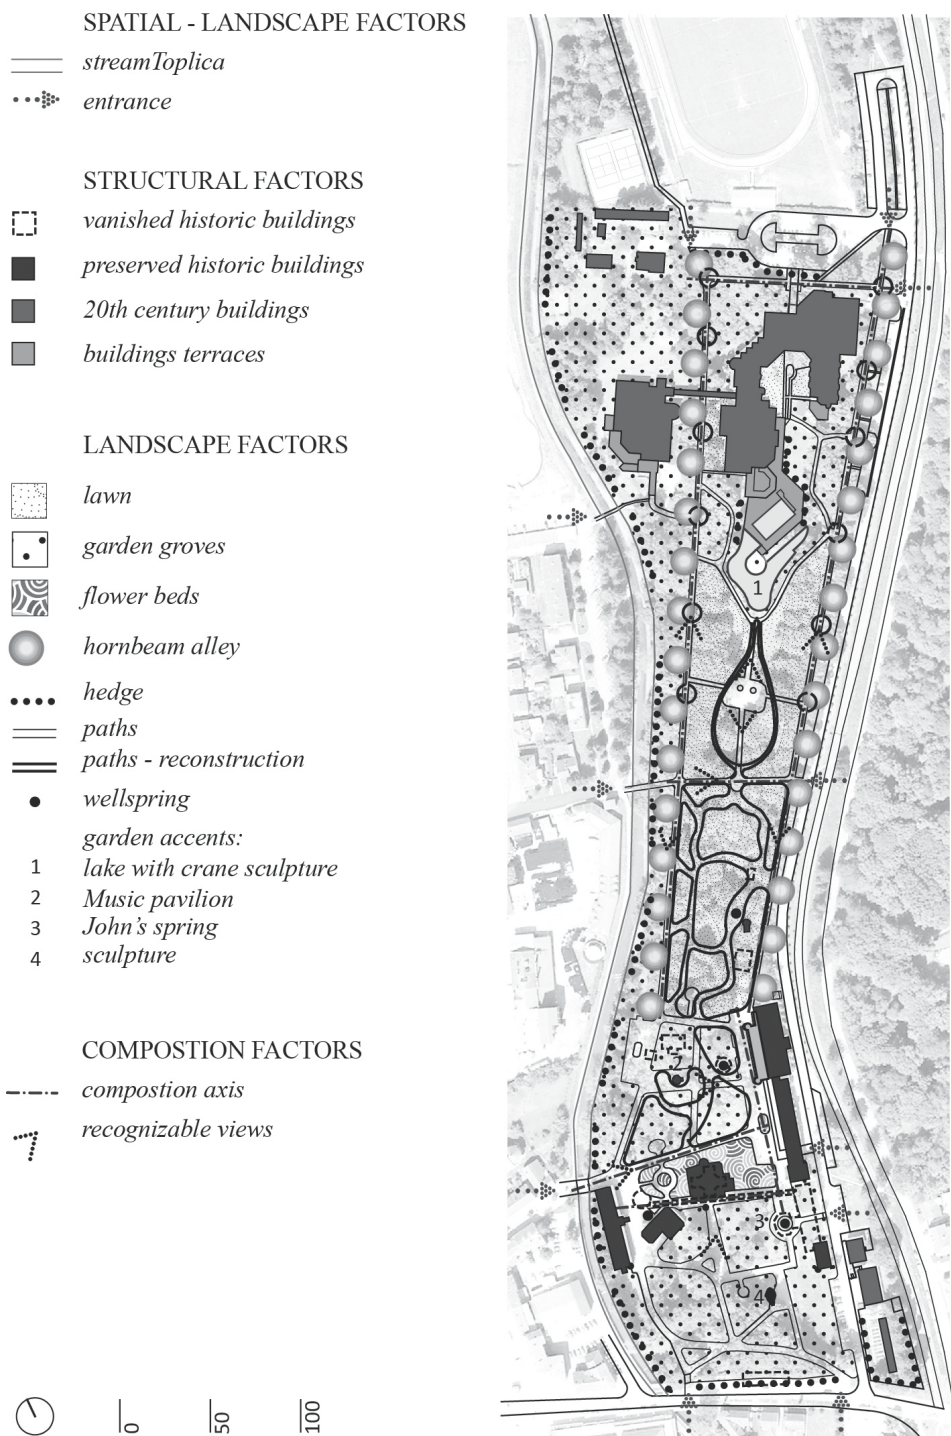
Figure 7. Landscape composition – garden renewal postulate

The historical ambiance was partially restored with the restoration of historical promenades and paths. The two missing historical areas will be reconstructed – the lawn in the central part of the garden and a tangle of winding trails south of the lawn. Historical promenades and paths were adjusted to the present-day conditions, but they retained the former direction, form and concept. Tree avenues are the only original garden factor today in the park, but without the historical semicircular rest areas (seating niches). Rest areas will be reconstructed on the basis of historical sources and information about their position and size, but not in the Northern part of the garden where that is not possible now because of the hotel building. The garden composition is being reconstructed, what is important for the reconstruction of garden interiors

which recreate the former garden atmosphere and the character of the area. This mainly refers to the restoration of lawns, groves, flower plantations, the axis of composition and perspective.
